Manhole Inspection Summary

Manhole # S41II_003MH

Insp Date: **6/22/09 10:31 AM**

Location Address: **1631 CAROLINE ST**

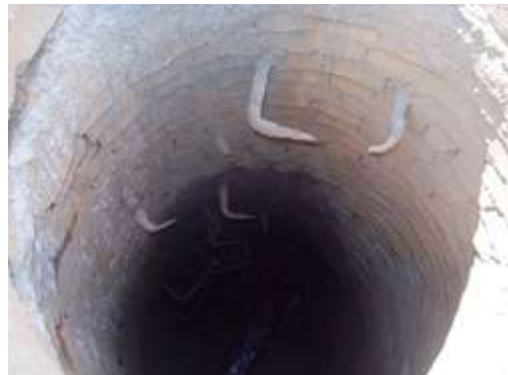
Defect 2

Steps Count: **9** Missing: **5** ☒ **Corroded**

MISSING CORRODED STEPS

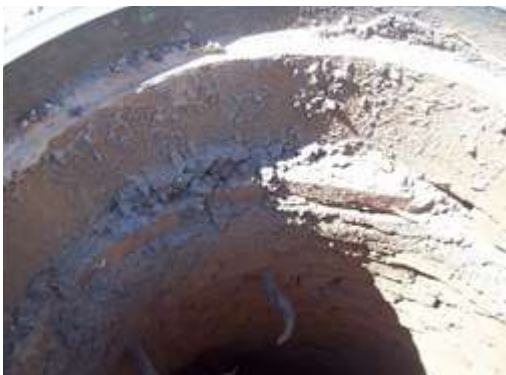
Defect 1

Frame Offset: **2** (in.) Condition: ☒ Sound ☐ Cracked ☐ Leaks

FRAME OFFSET

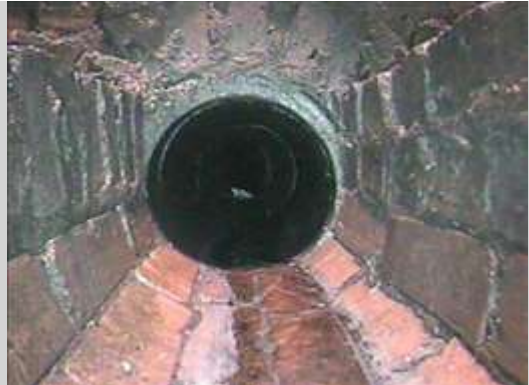
12 O'Clock Outflow

8 in. Circular Gravity Sewer
Pipe Out @ 12 O'Clock

Pipe Height: (in.) Direct
Pipe Material: **Clay** ☐ Pipe Lined
Invert Depth: **13.34** (ft.) Flow Characteristics: **Fast**
Deposits: ☒ None ☐ Mud ☐ Sludge ☐ Debris ☐ Grease
Silt Depth: (in.) Deposits Extent:
Infiltration: **None** Pipe Seal Cond: **Sound**

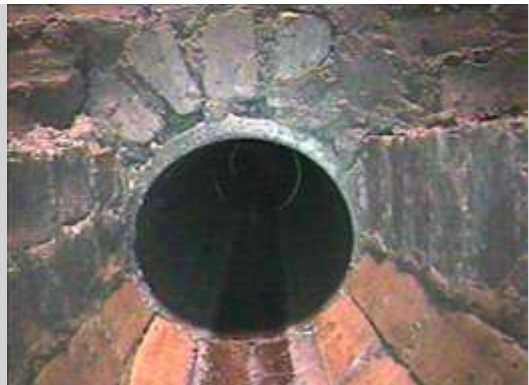
6 O'Clock Inflow

8 in. Circular Gravity Sewer
Pipe In @ 6 O'Clock

Pipe Height: (in.) Direct
Pipe Material: **Clay** ☐ Pipe Lined
Invert Depth: **13.27** (ft.) Flow Characteristics: **Fast**
Deposits: ☒ None ☐ Mud ☐ Sludge ☐ Debris ☐ Grease
Silt Depth: (in.) Deposits Extent:
Infiltration: **None** Pipe Seal Cond: **Sound**
